015/2021

**HVAC  
TUBE SHEET  
EROSION PROTECTION**

TUBE SHEET COATING  
MARCH, 2021

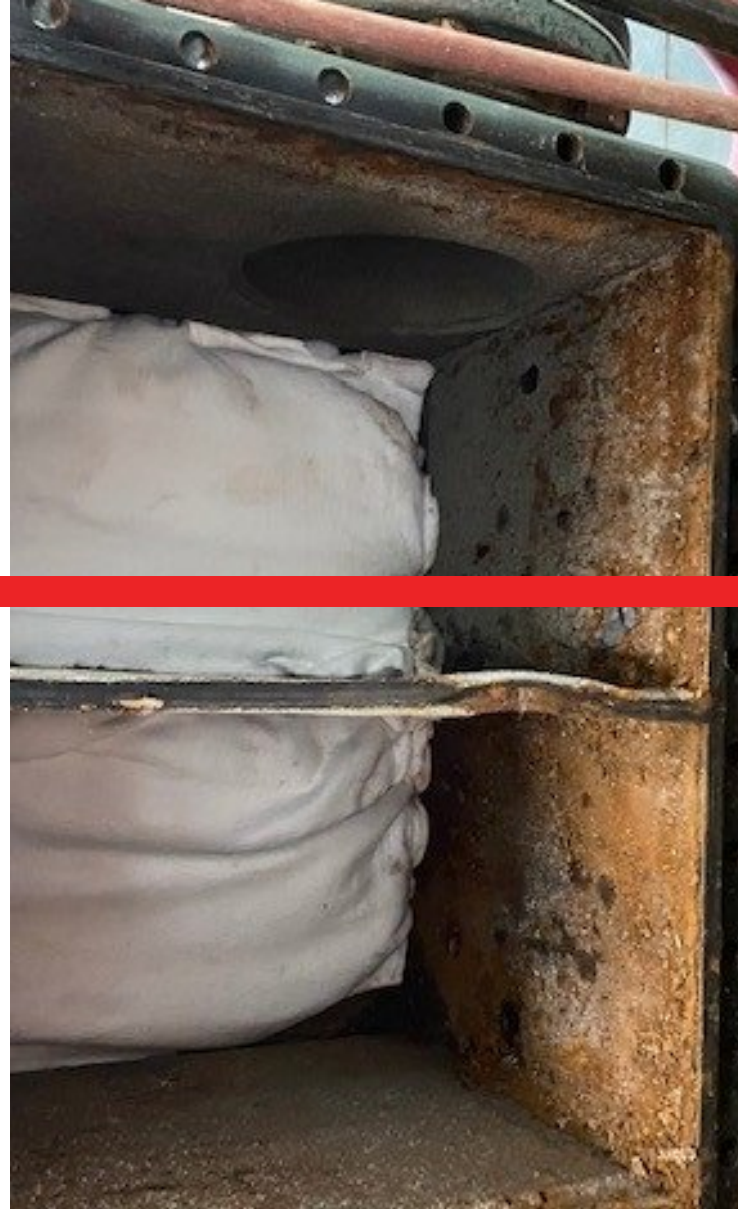
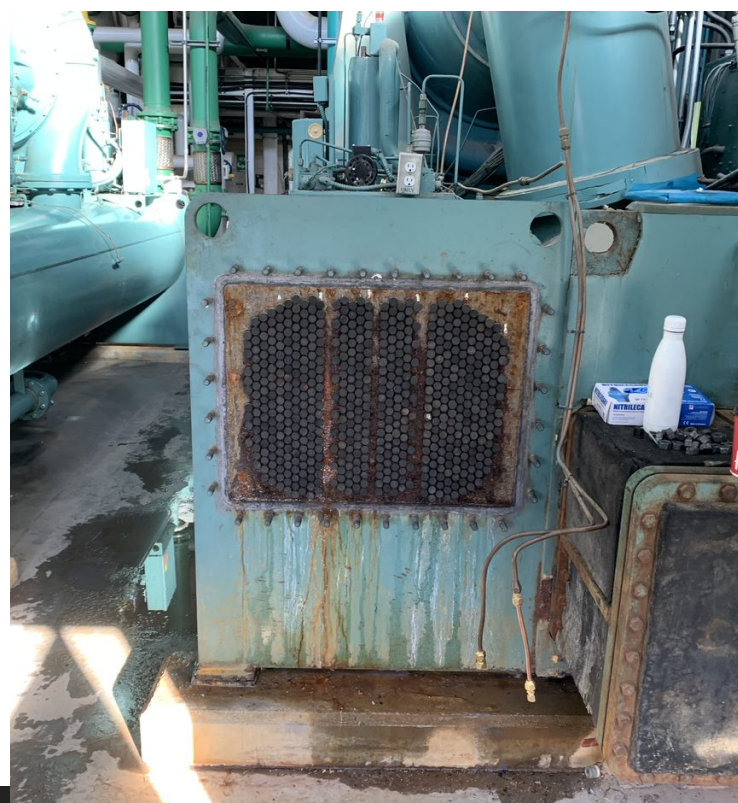
A large PPE manufacturer located in Eastern Ontario was experiencing corrosion issues in some of their chiller units.

Chiller units are a vital part of any heating or air conditioning system. Failure to quickly protect these units allows galvanic corrosion to take place, resulting in wastage and metal loss on the tube sheet around the coolant tubes. Left untreated, the loss of metal can cause leakage of the coolant and contamination of the chilled water.

Corrosion is not restricted to the tube sheet, the water box and end covers can also be affected

The unit was sandblasted by the maintenance crew of the manufacturer bringing the unit to near white metal. Belzona 1121 (Super XL Metal) was used to repair the metal loss caused on the heavily corroded unit. Belzona 1121 (Super XL Metal) is a cold curing 100 % solids epoxy composite reinforced with silicon steel composite. It was chosen for its long overcoating window.

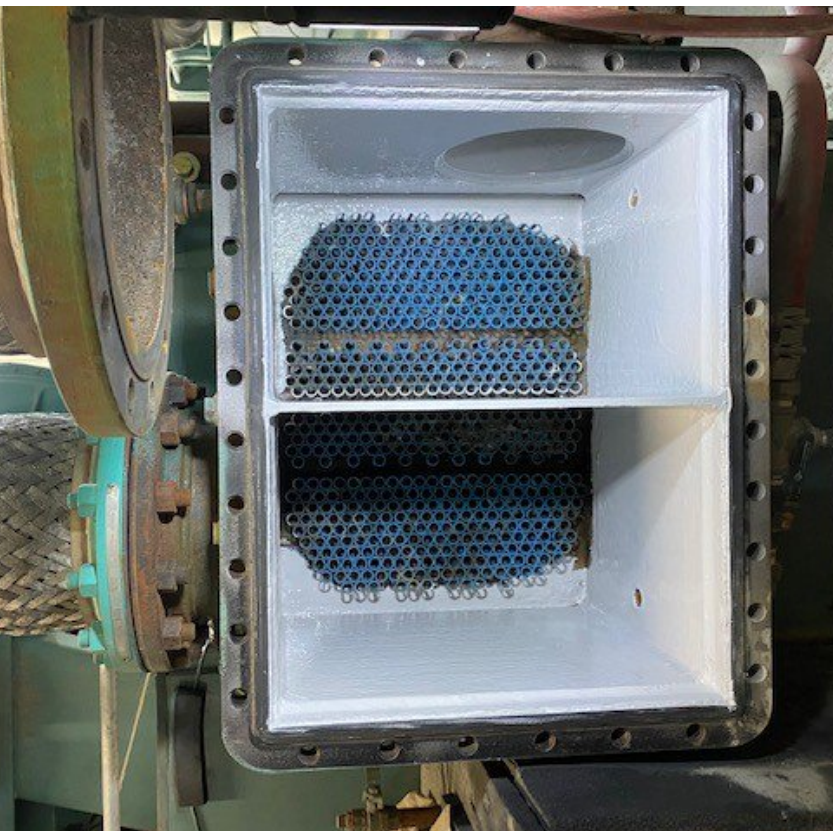
Once repaired, the unit was then coated using Belzona 1331. This coating also offers a long overcoating window that facilitated the application process for the contracting crew.

**Belzona 1331 was put to the test by the asset owner and after a year in service the product had shown no sign of deterioration. This next-generation coating offers excellent erosion-corrosion resistance, it is spray friendly and when necessary can be applied as a one coat system because of its high build properties.**

It was an easy decision for the customer to coat a larger unit as well using Belzona products. Belzona 1331 was used for this application. This is a two coat system for corrosion and erosion protection of equipment operating under continuous immersion.
