Adhesive Coating for Positive Grip Surfaces

BELZONA 1821

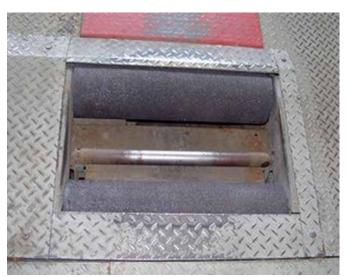
Drive Rollers - 12 years after the original application, still in excellent condition
