Repair System for Protection Against Abrasive Attack

BELZONA[®]
1814

Belzona 1814 is a cost-effective three-component repair system for the protection of surfaces subject to abrasive attack.

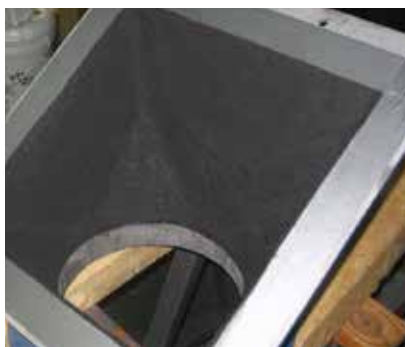
Protection for chutes and hoppers

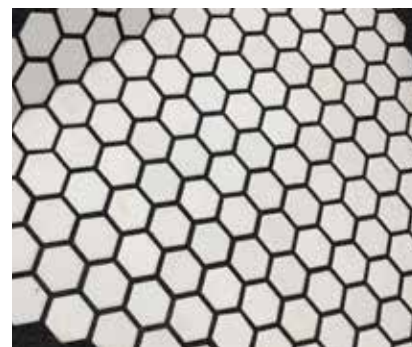
Grouting for alumina tiles

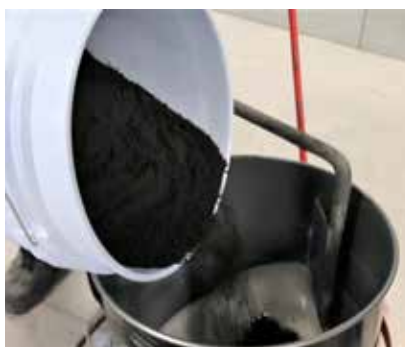
Simple mixing

Supplied as a three-part system, with a base, solidifier and aggregate, Belzona 1814 is easy to mix and apply without the need for specialist tools.

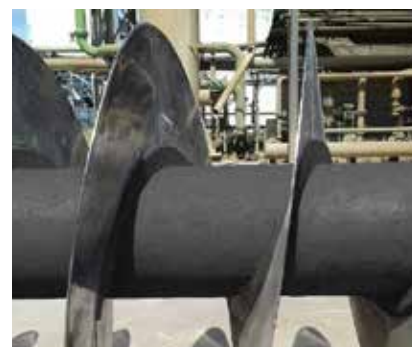
Easy application

The material is easy to mix and benefits from extended working life making it ideal for large areas. During application, no specialist tools are necessary and it is possible to apply thick and thin sections in one operation.
