BELZONA[®]
GREAT LAKES

**MANUFACTURING
DRIVE PULLEY
GRIP SYSTEM**

DRIVE ROLLER GRIP
DECEMBER, 2012

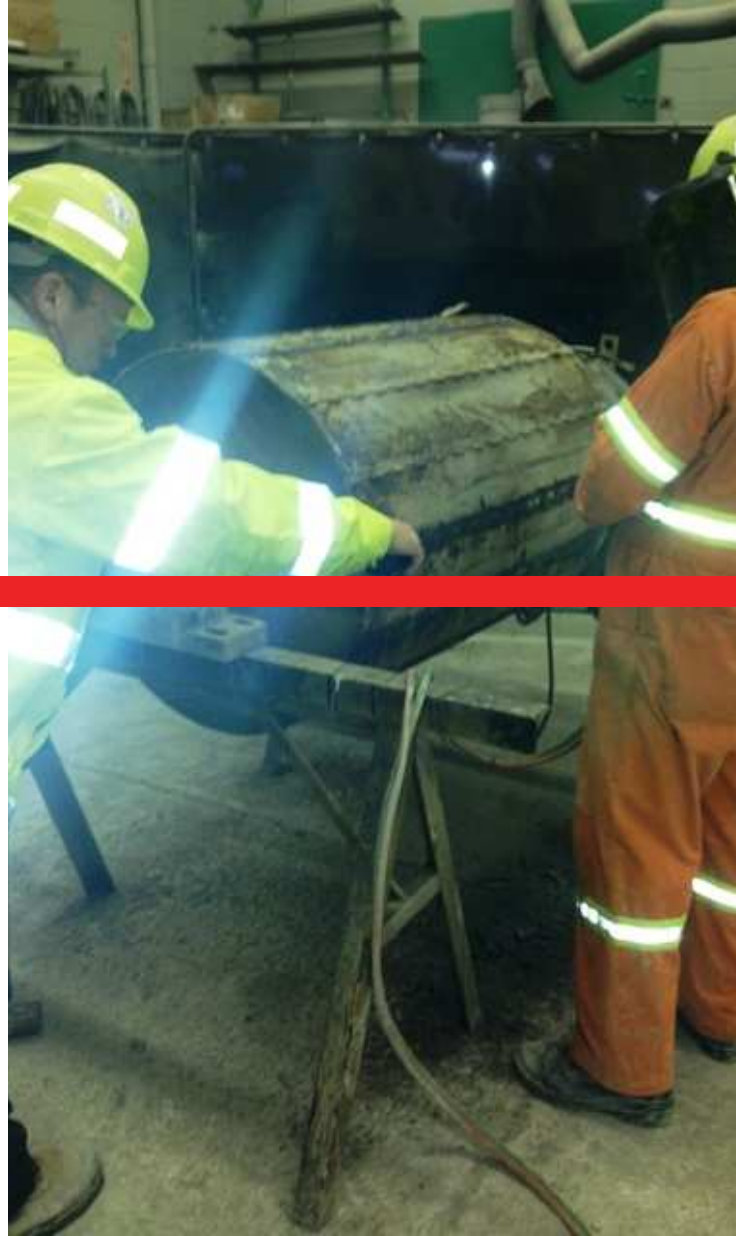
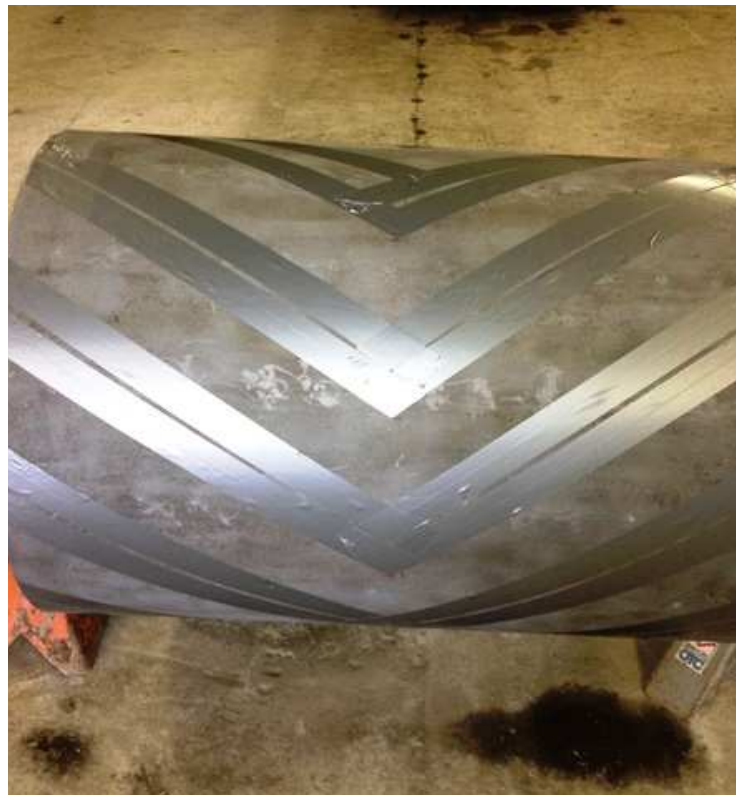
A customer in Brechin, Ontario had a drive roller which steel lagging failed to create traction. This created exposed edges problem which could possibly tear the belt.

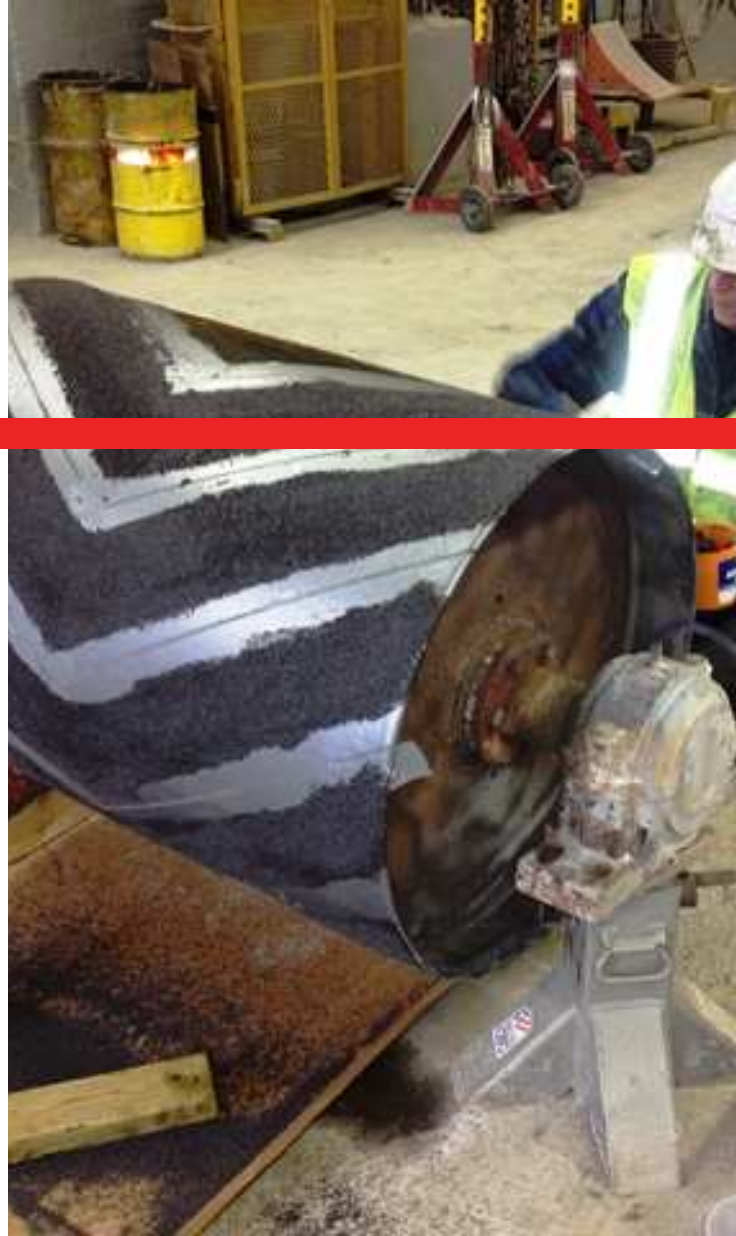
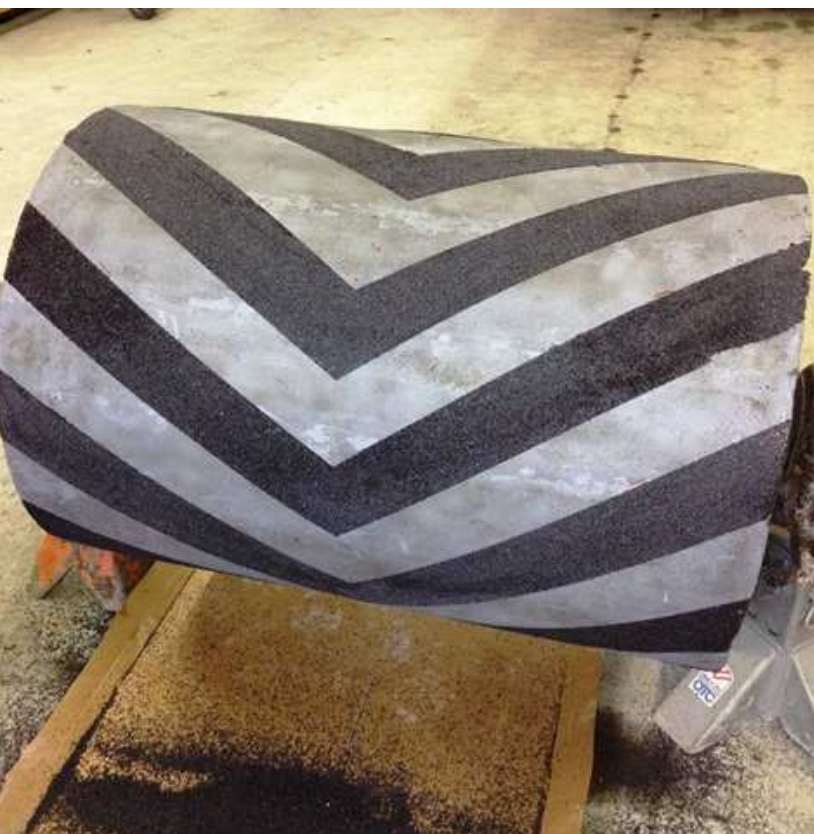
The surface was prepared by initially grinding the steel to create a clean surface and then abraded with the MBX Bristle Blaster to create the correct surface profile. After surface preparation, duct tape was then applied to chevron pattern. Belzona 1821 (Fluid Metal) was applied to the steel and Belzona 9211 (Supergrip) was applied over the Belzona 1821 (Fluid Metal).

The whole application was completed in one working day for a fraction of the cost of conventional repairs or replacement. The durable positive grip system eliminated belt slippage and protected the drive roller from abrasion and corrosion.
